Geotechnical Completion Report

99 ESCOTTS ROAD STAGE 1, TUAKAU

HUGHES DEVELOPMENTS LIMITED

27 June 2019 Ref No: J00779

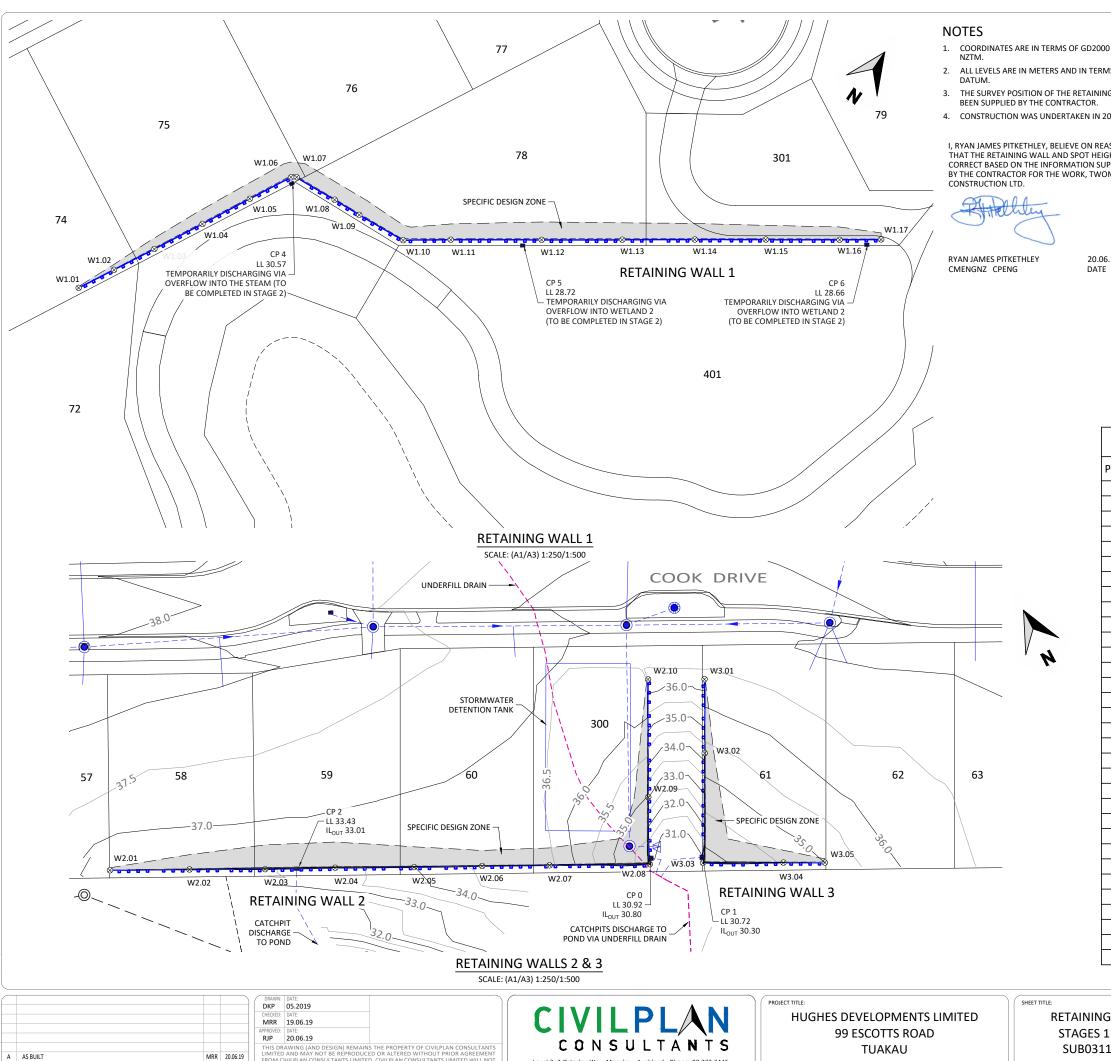
ISSUE STATUS: **AS BUILT** 1:250 / 1:500 DRAWING NUMBER: 2011-01-AB271 REV: A

RETAINING WALL ASBUILT PLAN STAGES 1 & 2 - DETAIL SHEET SUB0311/18 & LUC0489/18

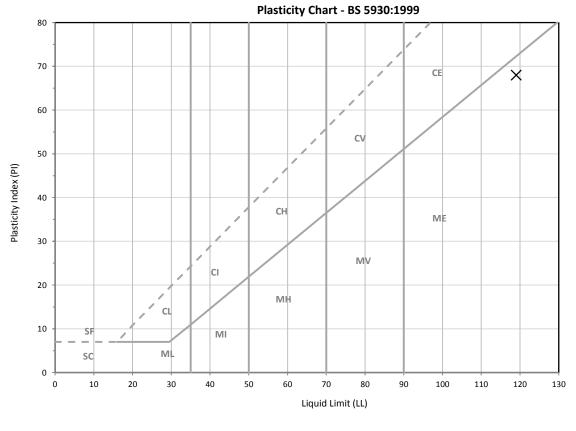
TEST DETAILS			
LOCATION	Description	99 Escotts Road, Tuakau			
	Data	N/A			
SAMPLE	Geotechnics ID	S19TG000162			
	Reference	Lot 3	Top Depth	0.50m	
	Sampled By	Others, Tested As Received	Bottom Depth	1.0m	
	Description	SILT, with some clay and some	sand, trace gravel; orange	brown. Moist.	
SPECIMEN	Reference	N/A	Depth	N/A	
	Description	N/A

Liquid Limit 119
Plastic Limit 51
Plasticity Index 68

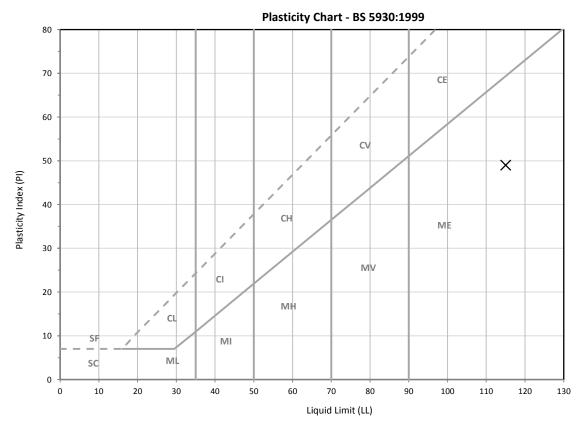
Description	99 Escotts Road, Tuakau		
Data	N/A		
Geotechnics ID	S19TG000163		
Reference	Lot24	Top Depth	0.50m
Sampled By	Others, Tested As Received	Bottom Depth	1.0m
Description	SILT, with some sand, minor to	some clay, trace gravel and	d trace rootelts; orange brown. Mois
Reference	N/A	Depth	N/A
Description	N/A		
	Data Geotechnics ID Reference Sampled By Description Reference	Data N/A Geotechnics ID S19TG000163 Reference Lot24 Sampled By Others, Tested As Received Description SILT, with some sand, minor to	Data N/A Geotechnics ID S19TG000163 Reference Lot24 Top Depth Sampled By Others, Tested As Received Bottom Depth Description SILT, with some sand, minor to some clay, trace gravel and the same sand.

Liquid Limit 115 Plastic Limit 66 Plasticity Index 49

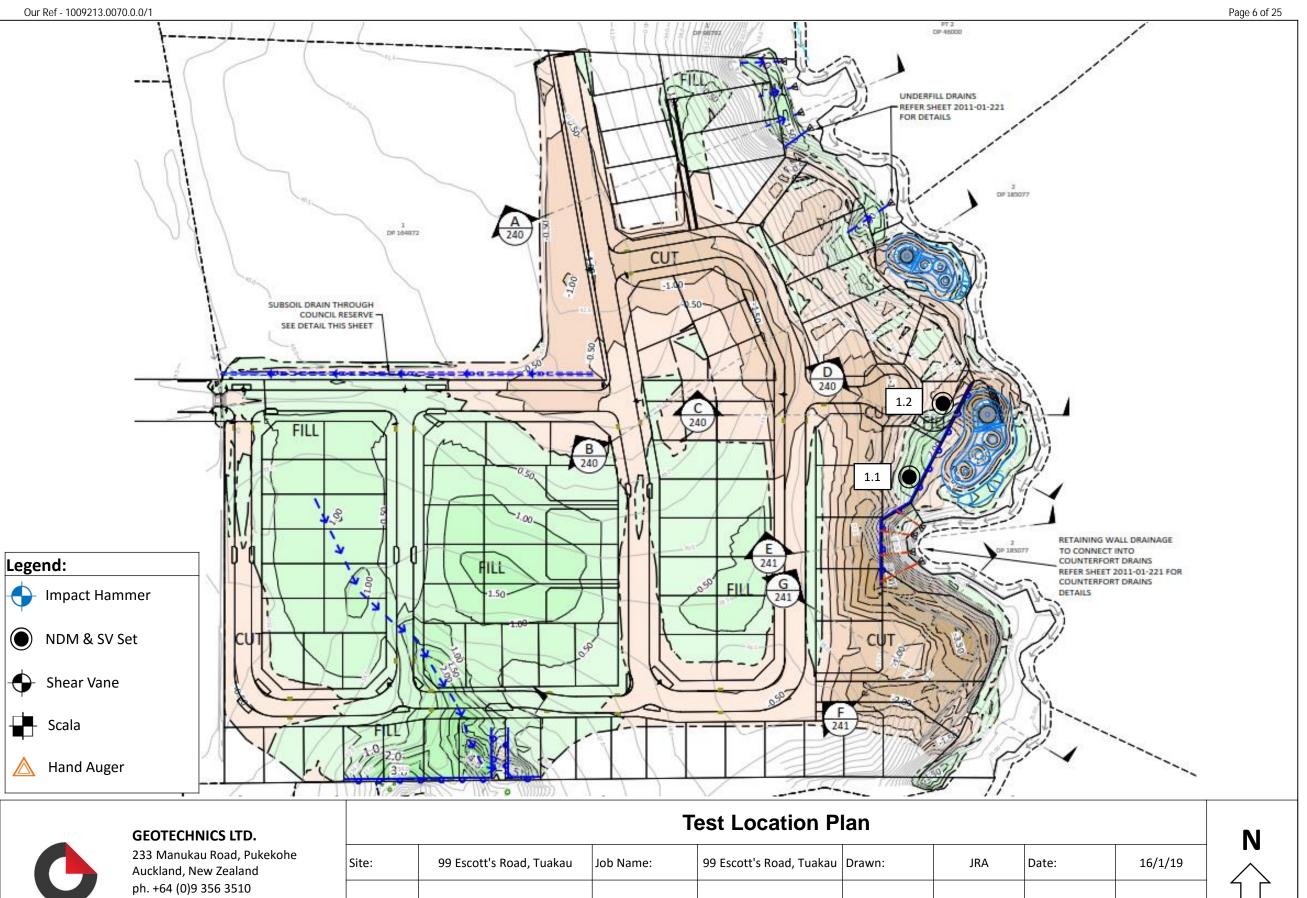
Test Location Plan													
Site:	99 Escott's Road, Tuakau	Job Name:	99 Escott's Road, Tuakau	Drawn:	JRA	Date:	16/1/19							
Location:	Retaining Wall Backfill	Job No.:	1009213.0070.0.0/1	URN:	1	Date:	16/1/19							
		Lab Ref:	- N/A	Scale:	Not to Scale	Rev.:	1

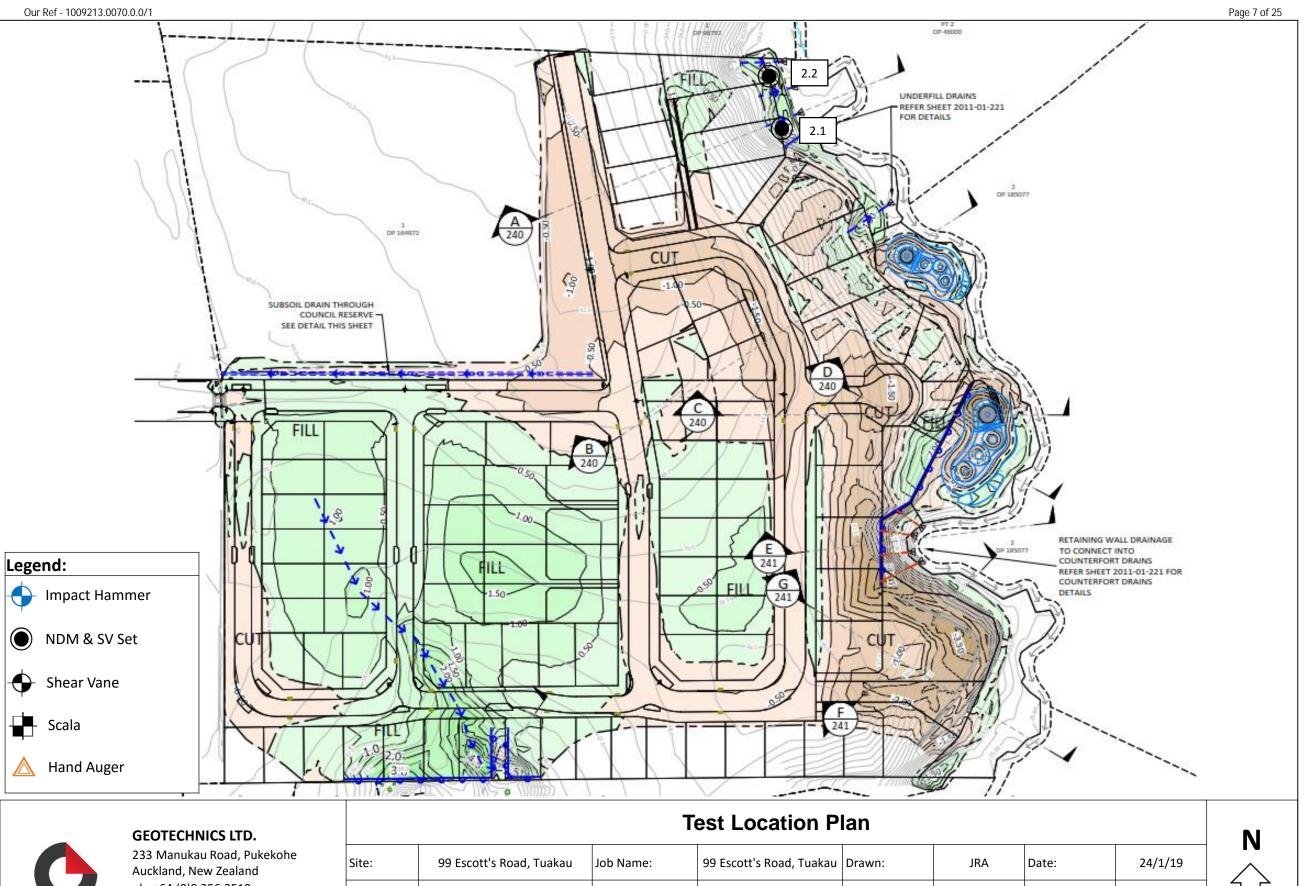
Test Location Plan													
Site:	99 Escott's Road, Tuakau	Job Name:	99 Escott's Road, Tuakau	Drawn:	JRA	Date:	24/1/19							
Location:	Stage 2- Fill Area	Job No.:	1009213.0070.0.0/1	URN:	2	Date:	24/1/19							
		Lab Ref:	- N/A	Scale:	Not to Scale	Rev.:	1

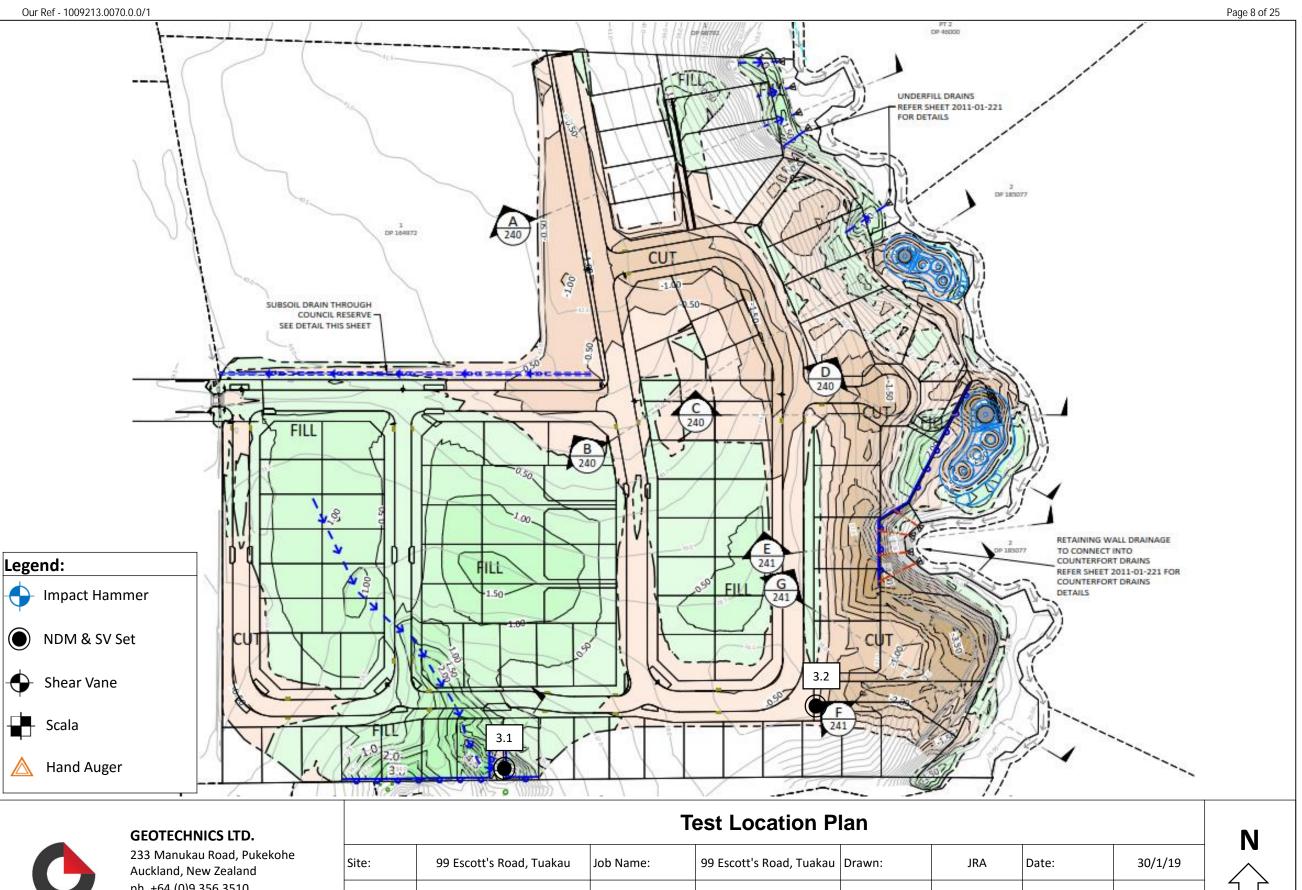
lest Location Flan													
Site:	99 Escott's Road, Tuakau	Job Name:	99 Escott's Road, Tuakau	Drawn:	JRA	Date:	30/1/19							
Location:	Fill Areas	Job No.:	1009213.0070.0.0/1	URN:	3	Date:	30/1/19							
		Lab Ref:	- N/A	Scale:	Not to Scale	Rev.:	1

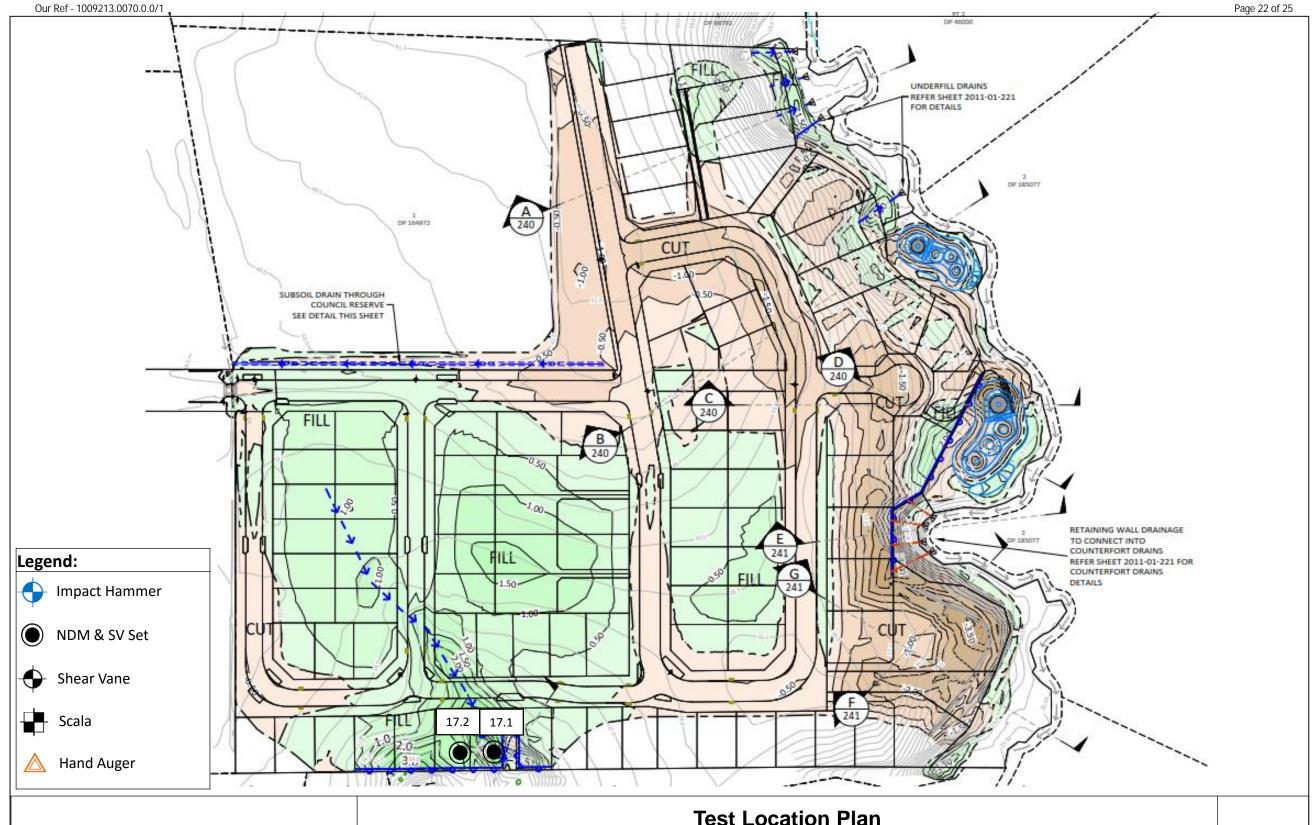
Test Location Plan									
Site:	99 Escott's Road, Tuakau	Job Name:	99 Escott's Road, Tuakau	Drawn:	VIVE	Date:	26/4/19			
Location:	South RW Fill Area	Job No.:	1009213.0070.0.0/1	URN:	17	Date:	26/4/19			
		Lab Ref:	- N/A	Scale:	Not to Scale	Rev.:	1

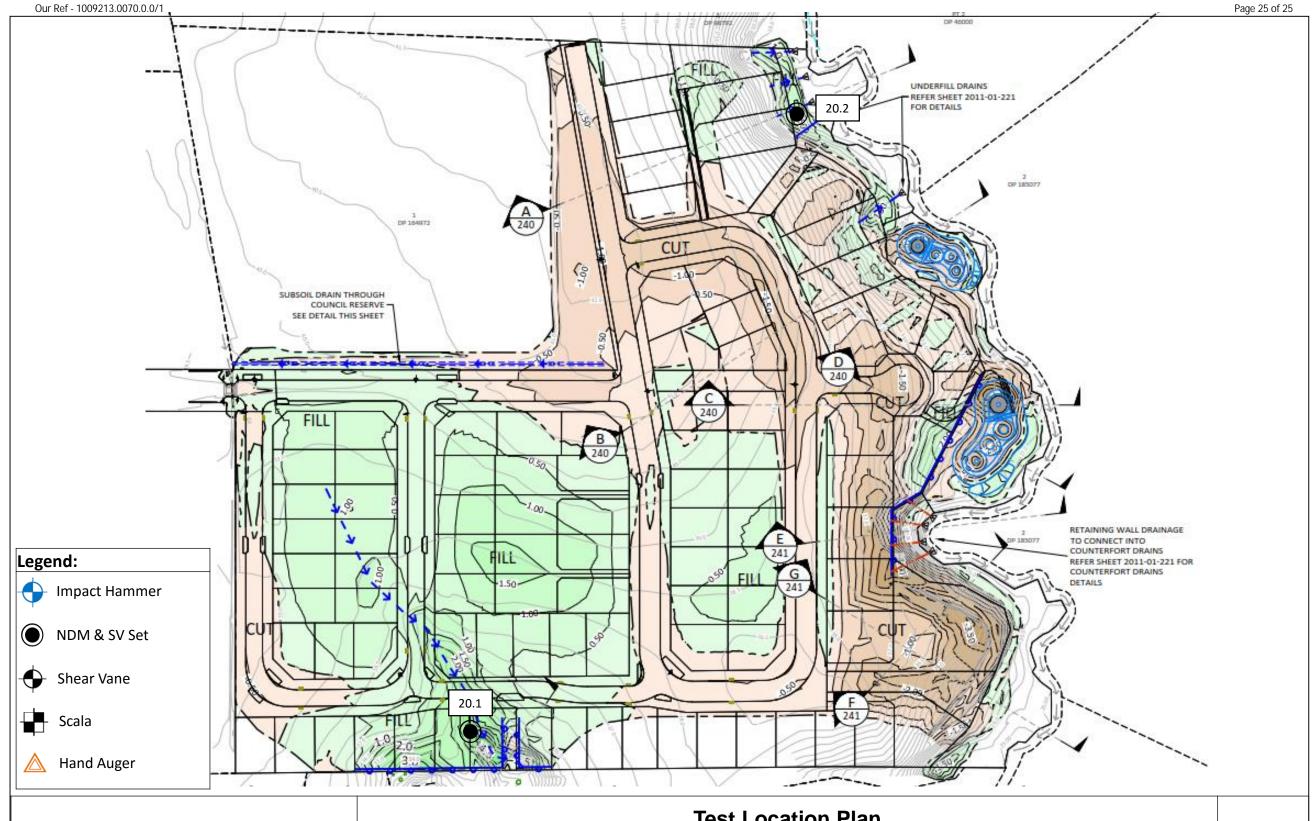
Test Location Plan									
Site:	99 Escott's Road, Tuakau	Job Name:	99 Escott's Road, Tuakau	Drawn:	JRA	Date:	3/05/19			
Location:	South RW Fill Area	Job No.:	1009213.0070.0.0/1	URN:	19	Date:	3/05/19			
		Lab Ref:	- N/A	Scale:	Not to Scale	Rev.:	1
